CASE HISTORY

CH-056

FASTONITE 700 REPAIRS HURRICANE DAMAGED TEXAS SWIMMING POOL

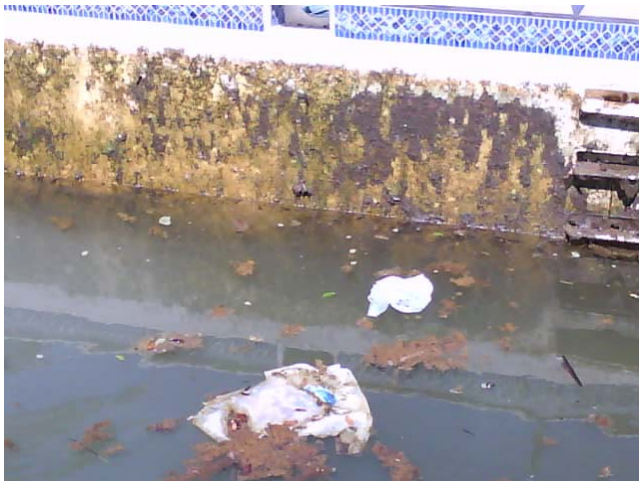
THE CHALLENGE: When Hurricane Ike tore through coastal Texas in the fall of 2008, it left a swath of damage which took months to repair. One such repair was the family swimming pool of a Galveston Bay waterfront home that was filled with debris and brackish water for over six months while the family house was being repaired after storm damage and flooding. After long exposure to bay water, the plaster surface was covered in barnacles and weakened by exposure to salt water.

Appearance during initial draining

THE SOLUTION: Workers drained the pool and removed the debris which included telephone poles, shrimp and a snake. One worker described the pool as looking like “a science project”. The walls were scraped to remove marine growth then acid washed, rinsed, and ground flat using diamond grinders. At this stage, the plaster was seen to be in a patchy, weakened condition.

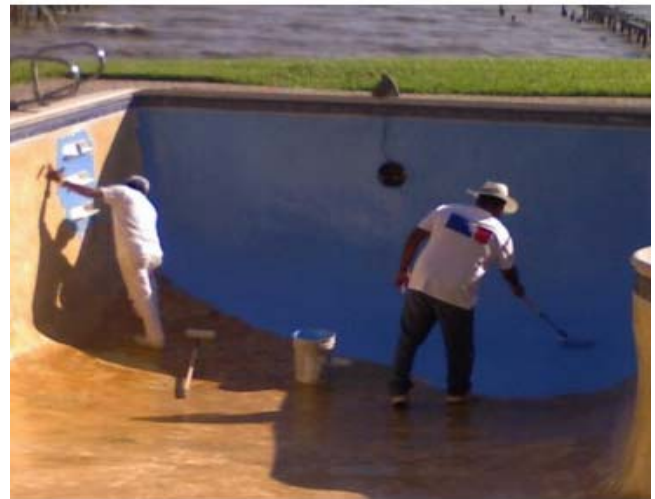
After this cured over night, some isolated large blisters were found where the plaster was so weak it had split at a depth of 1/8”. The blisters were cut out using a sharp knife and the weak plaster underneath was removed by scraping with a straight screwdriver until a firm substrate was reached.

First Fastonite 700 application over sealer

First, **BIO-SEAL 192**, a pure liquid epoxy designed to penetrate and reinforce porous surfaces, was applied using rollers to seal the surface. After it cured for a few hours, the first coat of **FASTONITE 700**, tinted to a rich Mediterranean Blue, was also applied by rollers.

The contractor used **BIO-FIX 911**, a Kevlar® reinforced “5 minute” epoxy repair compound to smooth and fill the blister pockets. Consequently, the final coating was possible within 5 minutes of application so as to avoid extending the overcoating interval unnecessarily.

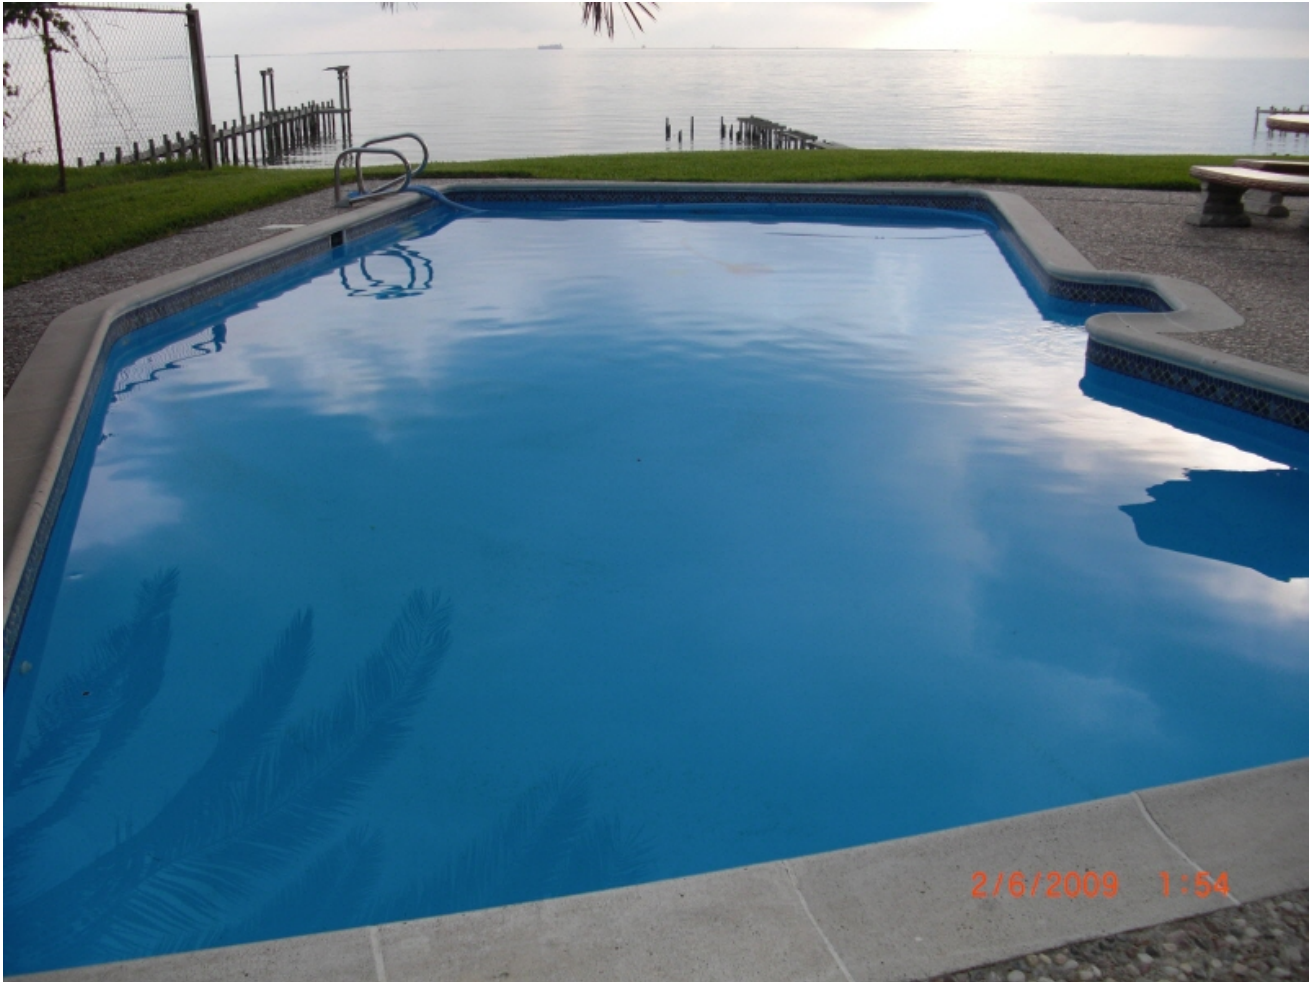
Finished pool – Galveston Bay in background

RESULT: The pool was closely examined before filling to ensure no more blistering “surprises” were found. Once the quality of the coating was confirmed, the pool was refilled with water after a 24 hour curing period. The pool is now restored to a beautiful appearance and due to the **FASTONITE** lining, it will consume only a fraction of the pool chemicals previously used.

The final coat of Fastonite was applied within the recommended overcoating interval and, in some cases, within minutes of the **BIO-FIX 911** repair.
