CASE HISTORY

CH-056

FASTONITE 700 REPAIRS HURRICANE DAMAGED TEXAS SWIMMING POOL

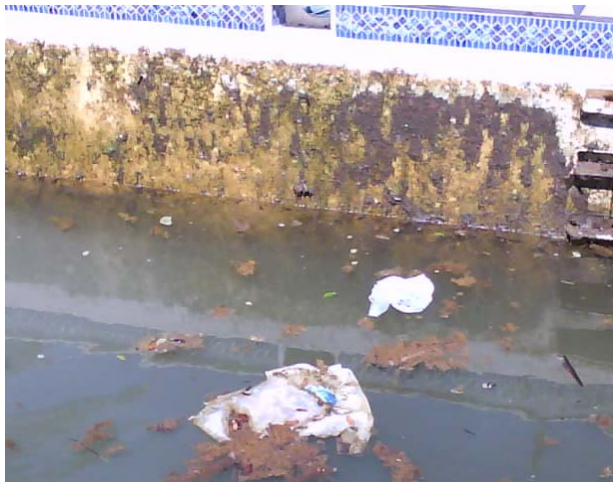
THE CHALLENGE: When Hurricane Ike tore through coastal Texas in the fall of 2008, it left a swath of damage which took months to repair. One such repair was the family swimming pool of a Galveston Bay waterfront home that was filled with debris and brackish water for over six months while the family house was being repaired after storm damage and flooding. After long exposure to bay water, the plaster surface was covered in barnacles and weakened by exposure to salt water.

Appearance during initial draining

THE SOLUTION: Workers drained the pool and removed the debris which included telephone poles, shrimp and a snake. One worker described the pool as looking like “a science project”. The walls were scraped to remove marine growth then acid washed, rinsed, and ground flat using diamond grinders. At this stage, the plaster was seen to be in a patchy, weakened condition.

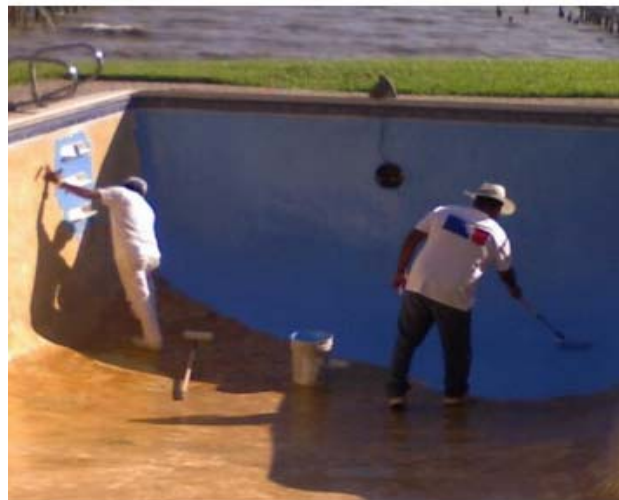
After this cured over night, some isolated large blisters were found where the plaster was so weak it had split at a depth of 1/8”. The blisters were cut out using a sharp knife and the weak plaster underneath was removed by scraping with a straight screwdriver until a firm substrate was reached.

First Fastonite 700 application over sealer

First, **BIO-SEAL 192**, a pure liquid epoxy designed to penetrate and reinforce porous surfaces, was applied using rollers to seal the surface. After it cured for a few hours, the first coat of **FASTONITE 700**, tinted to a rich Mediterranean Blue, was also applied by rollers.

The contractor used **BIO-FIX 911**, a Kevlar® reinforced “5 minute” epoxy repair compound to smooth and fill the blister pockets. Consequently, the final coating was possible within 5 minutes of application so as to avoid extending the overcoating interval unnecessarily.

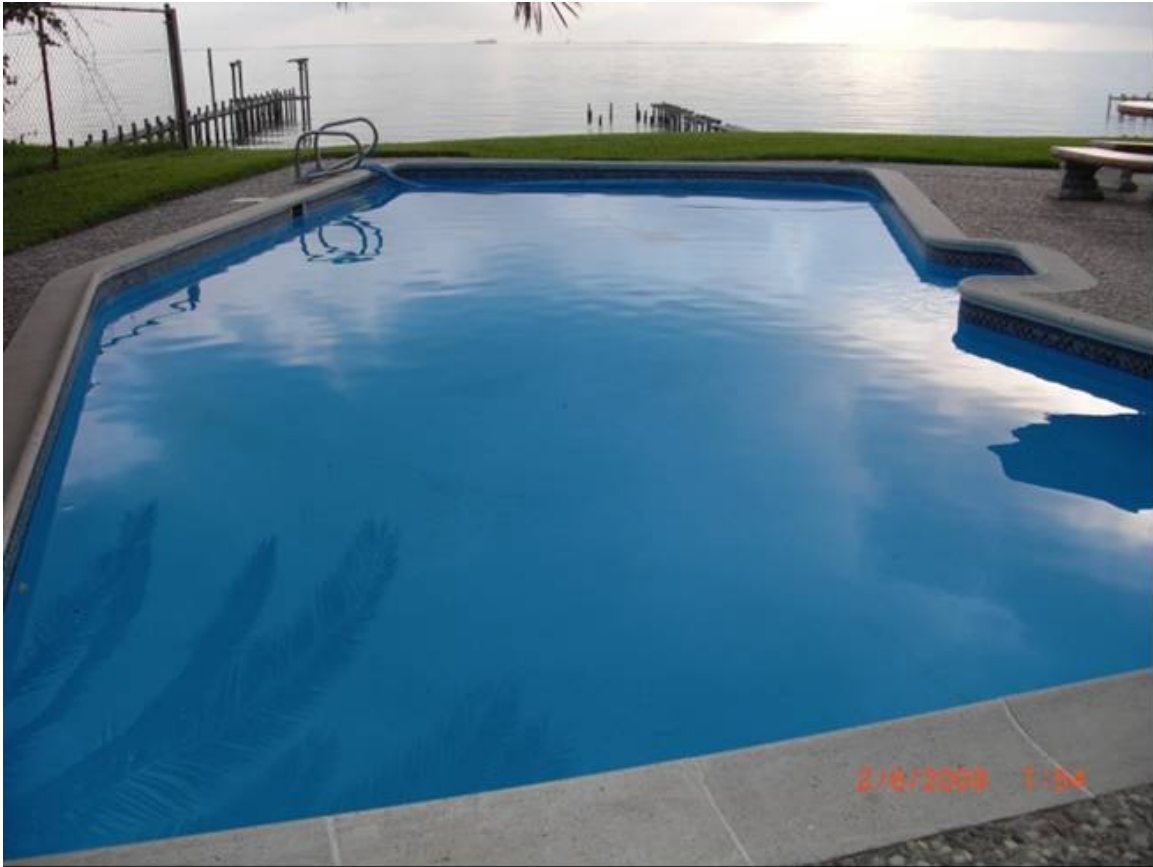
Finished pool – Galveston Bay in background

The final coat of Fastonite was applied within the recommended overcoating interval and, in some cases, within minutes of the **BIO-FIX 911** repair.

RESULT: The pool was closely examined before filling to ensure no more blistering “surprises” were found. Once the quality of the coating was confirmed, the pool was refilled with water after a 24 hour curing period. The pool is now restored to a beautiful appearance and due to the FASTONITE lining, it will consume only a fraction of the pool chemicals previously used.
