Report of Pool Liner Repair

University of Massachusetts Lowell Research Reactor

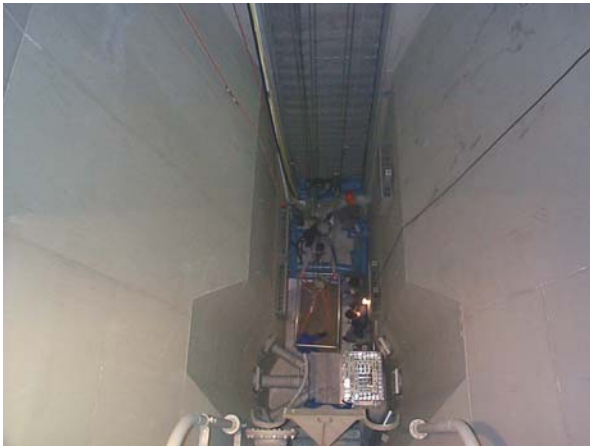
Figure 1 - Looking 30' down into the drained reactor end of the tank. The reactor has been moved to the isolated end beyond the top of the picture.

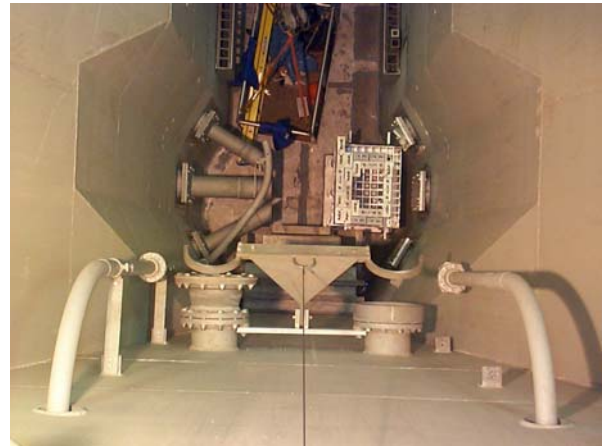
Figure 2 - Closer view showing beam tubes at left and new FNI facility at right. The reactor is normally stationed between the two when the tank is filled.
