Report of Pool Liner Repair

University of Massachusetts Lowell Research Reactor

Pool Liner Repair

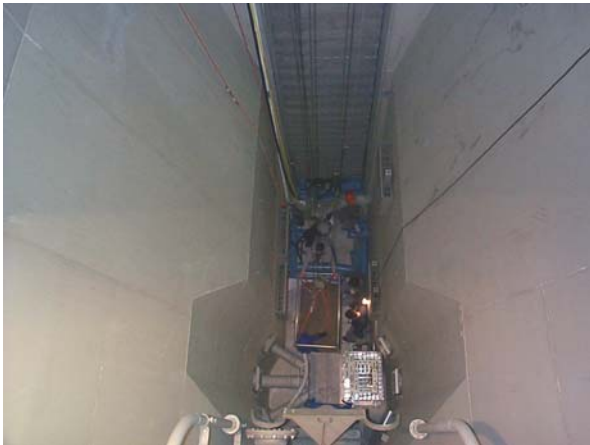
Figure 1 - Looking 30' down into the drained reactor end of the tank. The reactor has been moved to the isolated end beyond the top of the picture.

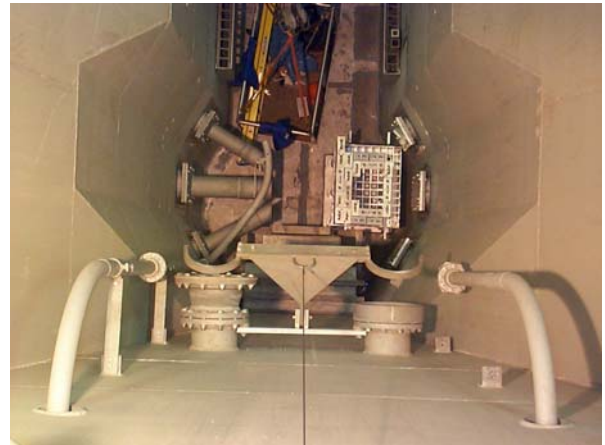
Figure 2 - Closer view showing beam tubes at left and new FNI facility at right. The reactor is normally stationed between the two when the tank is filled.

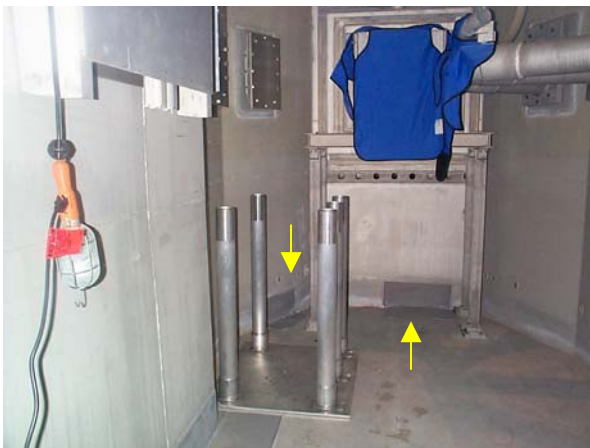
Fig. 3

Figure 3 – Inside the tank facing the experimental facilities. Beam tubes are located at the upper right. Thermal column is center and the base for the new FNI facility is center-left. Note the location of previous patches (yellow arrows).

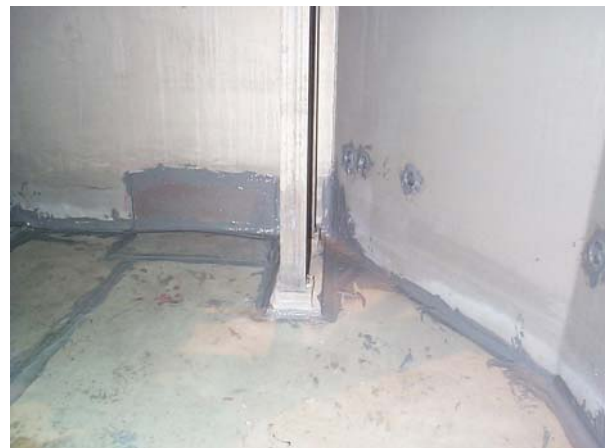
Fig. 4

Figure 4- Close view of epoxy applied to weld seams and area around the thermal column right support strut.

During the process of removing the three beam tubes and installing the fast neutron irradiator, a repair of the pool liner in the stall-pool section of the reactor pool was undertaken. The repair involved the use of a commercial-grade Kevlar enhanced epoxy coating (BioDur 561). The coating was applied by UMLRR staff to selected areas of the stall pool liner. These areas included weld seams along the pool floor, around the beam tube flanges, around the thermal column support footings, and on several areas of visually observed pitting (Figures 3 & 4). After re-filling the stall pool, no further evidence of leaking was observed. The sub-basement is checked monthly as part of a routine surveillance activity.
