CASE HISTORY ~ CH-033

BIO-DECK 190 REPAIRS AND PROTECTS 'TOWVEYOR" TRACK IN BUSY MATERIAL HANDLING FACILITY.

ALMOST NO WEAR AFTER FIVE YEARS OF GRUELLING SERVICE

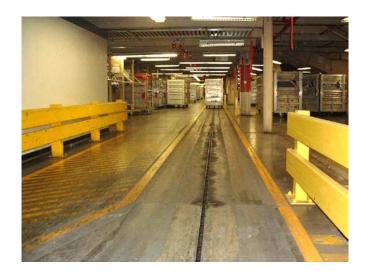
RESULT: The photograph above shows the track after five (5) years of continuous service. Wear measurements taken using a straight edge laid over the track show a typical wear of less than 35 mils after five years or less than 7 mils per year. As the surface has worn it has become velvet smooth and even more dense suggesting that the rate of wear will steadily decrease to an absolute minimum level over years of service for a probable service life in excess of 20 years.
