## CASE HISTORY:

### EXTERIOR TANK COMPOSITE REPAIR

**LOCATION** ECUADOR

**YEAR** 2016

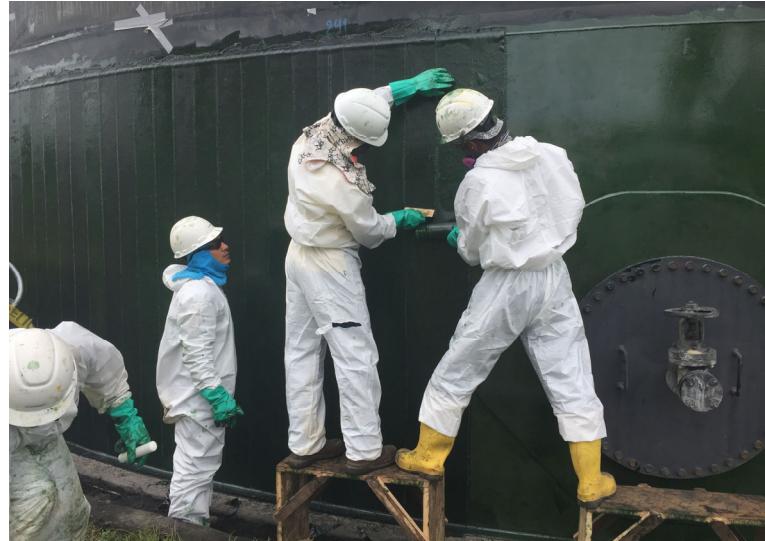
An oil and gas tank had experienced severe corrosion around the bottom ring of the structure. There was immediate need to rebuild the deteriorated surface and prevent further corrosion.

Surface preparation by power washing removed contaminants, loose rust, and previous paint.

The steel surface was first primed with a coat of BIO-SEAL 914 applied by roller. The carbon fiber was saturated on a work table prepared next to the job site using BIO-SEAL 190. Once saturated, these strips were rolled up, given to an applicator team, then unrolled onto the surface. The carbon application was applied in two meter strips, pressing each strip into the still wet 914 primer coat with aid of a flat edged tool to remove air bubbles. Successive layers of carbon were applied with an inch or so overlap creating a "single" carbon structure.

was taken not to let any epoxy cure for longer than 36 hours before being overcoated.
