## CH-054

### BIO-DUR 560 LINER INSTALLATION IN SEA LION ENCLOSURE

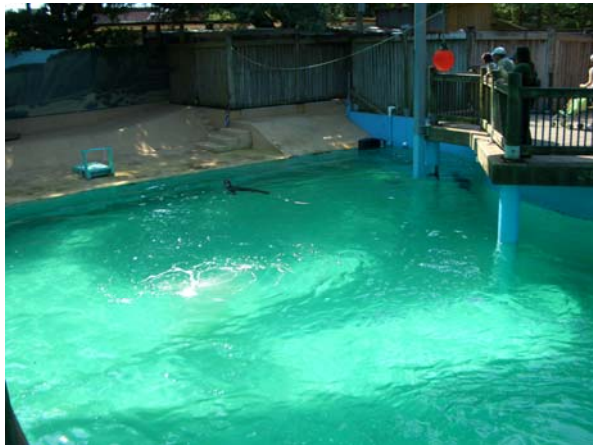
Sea Lion Enclosure before project

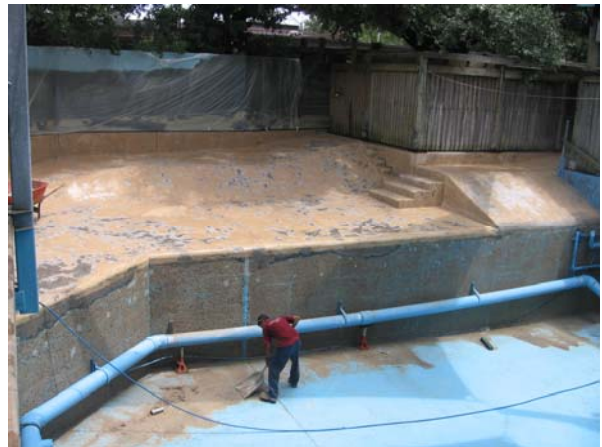
Preparation work in progress

**THE SOLUTION:** The coating contractor, Modern Maintenance of Spring, TX, met with zoo officials and TFT in a pre-award meeting to discuss requirements for timing, color etc. Because of the tight scheduling requirements and the need for a smooth coating it was necessary to apply the coating by spray. In order to satisfy environmental requirements the TFT solvent-free coating BIO-DUR 560 was chosen. This material was custom tinted to the specified color and especially engineered to have excellent UV resistance. Severe thunderstorms threatened serious delays during the last and most critical days of the project. Because of the extreme water tolerance of BIO-DUR 560 however the crew working in the rain was able to apply the entire waterline area using rollers.

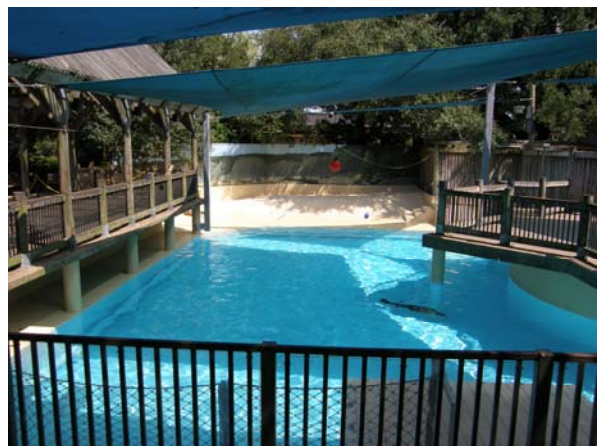
Completed project

**RESULT:** A fortunate break in the weather allowed most of the wall area and all of the floor area to be sprayed using 1/1 ratio heated, plural component airless equipment. The BIO-DUR 560 was very smooth and cured quickly to a hard and tough, Kevlar® reinforced liner. In addition the “beach” area was coated with BIO-GARD 257 to form a smooth, tough and UV resistant surface.

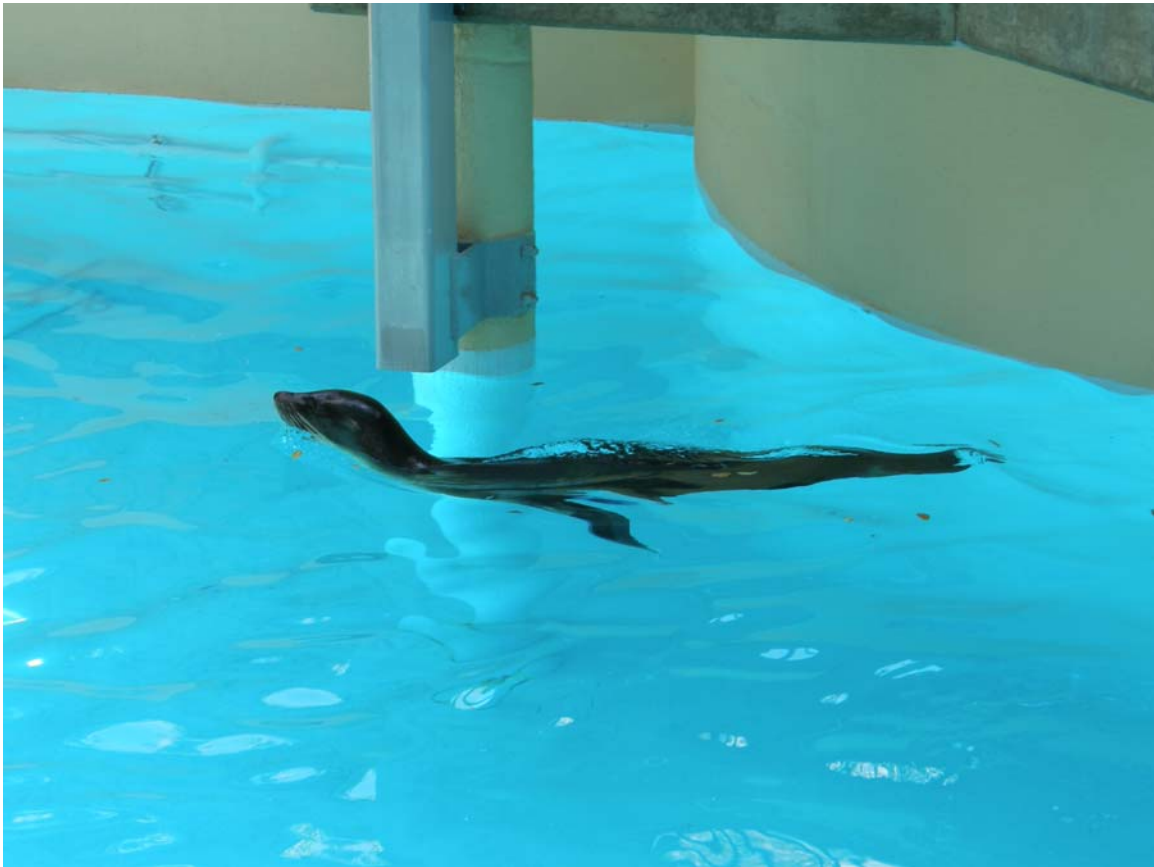
**CONCLUSION:** The color chosen by the zoo personnel creates an almost luminous effect in bright sunlight. Expansion joints and some minor cracks which were also treated during the liner application using special flexible membrane have been positively sealed and have effectively vanished from view after coating with the BIO-DUR 560 lining. Both the zoo personnel and Sea Lion inhabitants are pleased with the restored pool.
