CASE HISTORY ~ CH-059

BIO-SEAL 197 SEALS AND REINFORCES STRENGTHENED SILO SUPPORTS

PRODUCT: BIO-SEAL 197 YEAR: 2010 LOCATION: PEARLAND, TX

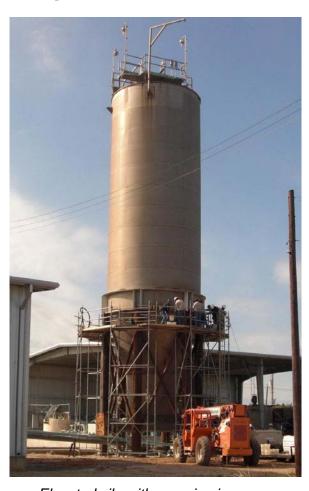
Elevated silo with pumping in progress

THE SOLUTION: The engineering solution was to install oversize new support legs around the existing legs with additional diagonal bracing. To permanently seal and reinforce the structure, the annulus between the old and new legs was filled with a slurry of BIO-SEAL 197 liquid epoxy resin and #4 blasting sand.

Lab testing at TFT determined a range of sand concentrations that would optimize pumpability and epoxy consumption. Threaded ports were installed at the tops of the fabricated outer legs to allow easy pumping and internal air release. The installation crew, located on a catwalk at the top of the legs, blended the BIO-SEAL 197 epoxy components with #4 blasting sand which was then transferred to a custom fabricated hopper feeding a 2" diaphragm pump. The outlet of this pump was then led sequentially to the new legs, and the BIO-SEAL 197 slurry was pumped into each leg over a period of about 10 minutes.
