CASE HISTORY ~ CH-072

CRUDE OIL STORAGE TANK REPAIR USING CARBON FIBER REINFORCED BIO-SEAL 192HB

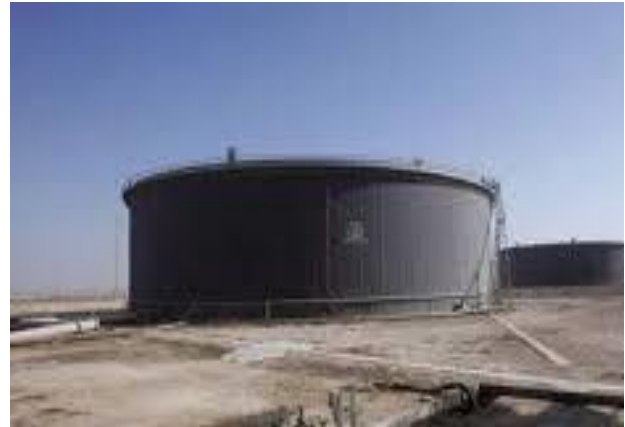
Crude Oil Storage Tank – “COST”

IMPLEMENTATION: A team of experienced installers working on scaffolds first cleaned to exterior surface by water jetting and light hand scraping to produce a firm surface for coating. BIO-DUR 290 was then applied by roller to a nominal thickness of 8 – 10 mils.

BIO-SEAL 192HB saturation resin is a 1/1 by volume, high build version of BIO-SEAL 192. Its high build properties assisted greatly in the application under the hot conditions. A total of three (3) layers of carbon reinforced fabric was applied circumferentially around the top course of the tank. It was imperative to observe overcoating times because of the ambient temperatures reaching as high as 120°F in the shade. As a rule of thumb overcoating was performed when the preceding coat had cured to a “gummy” condition.

After the last layer of carbon/epoxy was installed a final coat of locally sourced UV resistant paint was applied.
