CASE HISTORY:

COMPOSITE REPAIR OF FLARE LINES

PRODUCTS BIO-SEAL 192, BIO-DUR 560

LOCATION SOUTH AMERICA

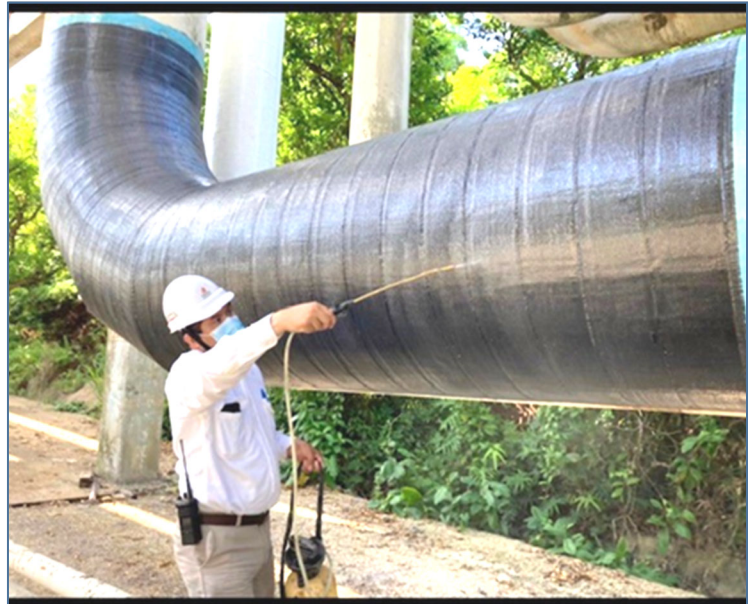
A technician is shown testing the completed application for leaks using a soap solution after the composite had cured.

Inspecting carbon fiber repair of pipeline.

18oz. bi-directional fabric in 12" width was field impregnated with BIO-SEAL 192 resin and applied spiral fashion over the BIO-DUR 560 primer with a 1", (2.5cm), overlap.

A coating was applied after QC testing in order to preserve the composite against UV degradation.
