Underwater Paint Job Takes Dresden Unit 1

A Step Closer to SAFESTOR → TFT BIO-DUR 560

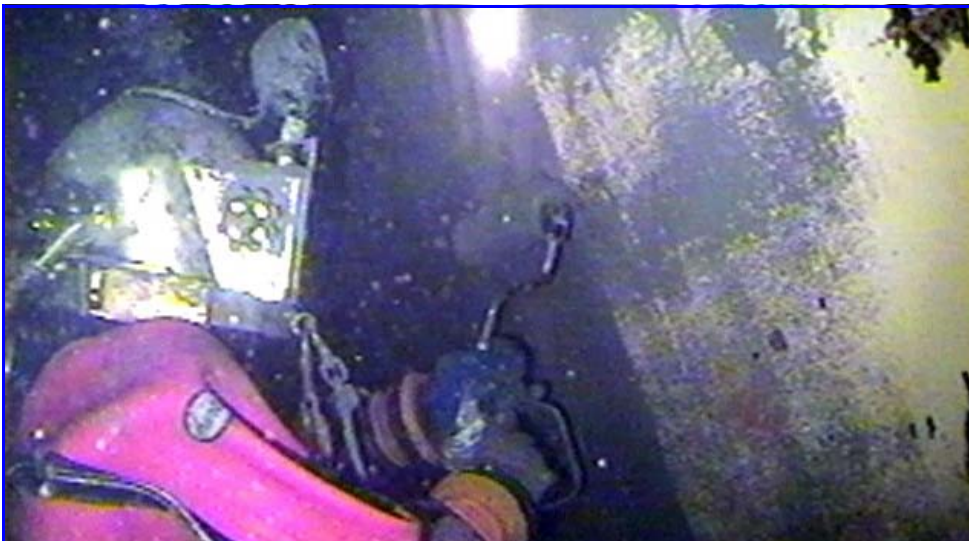
This guy is underwater! A UCC diver rolls on a coat of special epoxy to a wall of the Unit 1 Spent Fuel Pool. The epoxy, which will prevent the release of airborne contamination once the pool is drained, is applied by divers while they are submerged underwater.

The epoxy consists of two compounds that are held in separate chambers in a paint machine that sits next to the Unit 1 fuel pool. The paint is heated to 110 degrees and fed by hoses to the paint roller. The hoses are about 100 feet in length and run through a sleeve, which is heated to help maintain the proper paint temperature.

bined into a single hose and is mixed about six feet from the paint roller. A diver uses the roller to apply a single coat of epoxy (approximately 30 mills thick) to the walls of the fuel pool in much the same way someone would paint any other wall.

lowered into the water. Starting at the top of the fuel pool walls, they painted a 12-foot high area around the pool to create what Panozzo calls a “bathtub ring.”

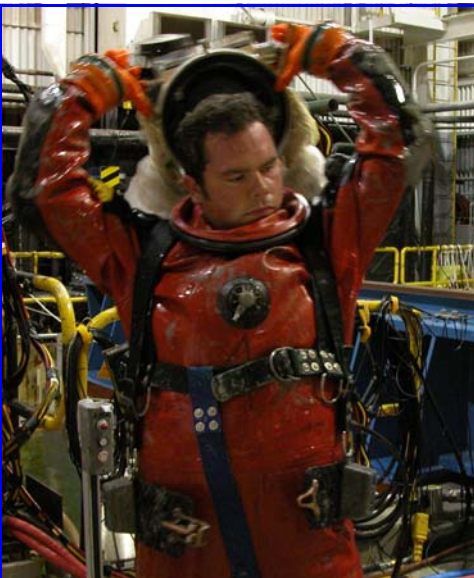
UCC Diver **Matt Crowell** pulls off his helmet after completing his shift in the Unit 1 Spent Fuel Pool. The divers work in two-man teams and are closely monitored to ensure that Nuclear, Industrial and Radiological Safety standards are maintained during the painting process.

The UCC divers typically perform two painting dives a day on Unit 1 – a three-hour dive in the morning and another three-hour dive in the afternoon. During each dive, two painters work as a team and every phase of the operation is closely monitored. A worker at the dive station desk maintains constant communication with the divers, while technicians at a Radiation Protection desk monitor dose levels and watch the painters via closed circuit TV.
