CASE HISTORY ~ CH-005

BIO-DUR 561 PROTECTS THE "WIND AND WATER" AREA OF A POWER STATION PIER.

PRODUCT: BIO-DUR 561 YEAR: 1998 LOCATION: PUERTO LIBERTAD SONORA, MEXICO

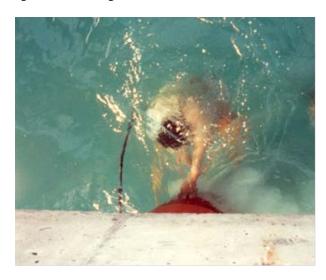
"Near White Metal" with randomly spaced islands of intact old coating. The BIO-DUR 561 applied as easily over the old coating residues as it did over bare steel. Since BIO-DUR 561 contains no solvents it cannot soften or weaken residues of old coatings – even antifouling paints. The freshly applied BIO-DUR 561 was not disturbed by even 2' – 3' wave action washing against the coating.

APPLICATION: Surface preparation was by hand-held pistols delivering 4,000psi seawater with beach sand entrained through a simple venture system. This very simple and inexpensive system worked perfectly in the shallow working depths of this project. The degree of blasting obtained was general equivalent to SSPC-SP10,
