## CASE HISTORY ~ CH-048

## BIO-FLOR 182 UPGRADES AND ENCAPSULATES HOSPITAL VINYL ASBESTOS TILE FLOORING.

PRODUCT: BIO-FLOR 182 YEAR: 2007 LOCATION: LA CROSSE, WI

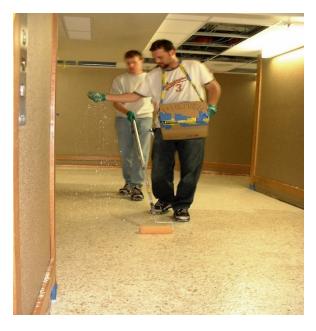
An un-pigmented BIO-FLOR 182 clear coat is then applied and while still uncured the colored vinyl chips are spread by "chicken-feeding" then rolled into the clear coat.

A colored BIO-FLOR 182 Base Coat is first applied using squeegee and roller then allowed to cure for about 4 hours until firm.

After the "Chip Coat" has cured for about 4 hours a final thin Glaze Coat of BIO-FLOR 182 Clear is applied. The floor is ready for unrestricted service after curing for about 12 hours at 77'F.
