# CASE HISTORY ~ CH-054

## BIO-DUR 560 LINER INSTALLATION IN SEA LION ENCLOSURE

PRODUCT: BIO-DUR 560

LOCATION: HOUSTON, TX

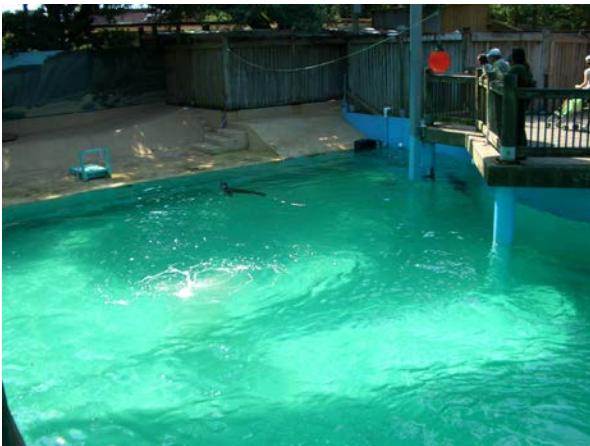
**THE CHALLENGE:** The sea lion enclosure at the Houston Zoo was ready for redecorating to upgrade the attraction. Although the applications were to be made “in the dry” it was understood that the concrete surfaces were liable to be moist after years of sea-water service. Houston summer weather which can generate thunderstorms in an instant was also a factor to be considered. A smooth, tough coating to provide years of service which was compatible with the application requirements was required.

Seal Lion Enclosure before project

**THE SOLUTION:** The coating contractor, Modern Maintenance of Spring, TX, met with zoo officials and TFT in a pre-award meeting to discuss requirements for timing, color etc. Because of the tight scheduling requirements and the need for a smooth coating it was necessary to apply the coating by spray. In order to satisfy environmental requirements the TFT solvent-free coating BIO-DUR 560 was chosen. This material was custom tinted to the specified color and especially engineered to have excellent UV resistance. Severe thunderstorms threatened serious delays during the last and most critical days of the project. Because of the extreme water tolerance of BIO-DUR 560 however the crew working in the rain was able to apply the entire waterline area using rollers.

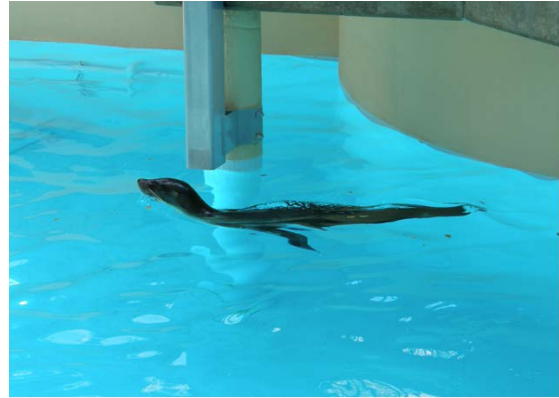
**RESULT:** A fortunate break in the weather allowed most of the wall area and all of the floor area to be sprayed using 1/1 ratio heated, plural component airless equipment. The BIO-DUR 560 was very smooth and cured quickly to a hard and tough, Kevlar® reinforced liner. In addition the “beach” area was coated with BIO-GARD 257 to form a smooth, tough and UV resistant surface.
