# THIN FILM TECHNOLOGY, INC.

## CASE HISTORY:

### GASOLINE TANK LINING – JAMAICA

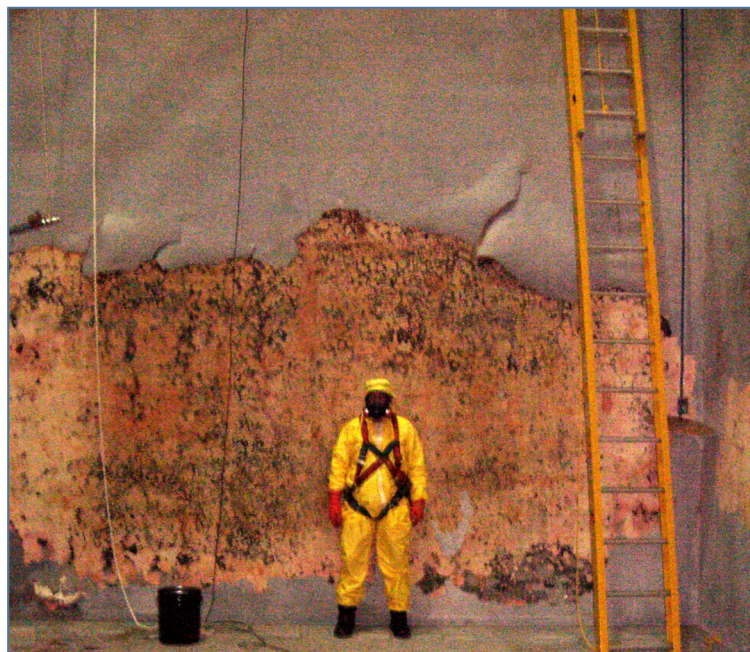
The steel surface was first primed with a wet coat of BIO-SEAL 192J applied by plural spray. The fiberglass cloth was then laid onto this prime coat and more 192J was sprayed over it. Hard rollers were then used to wet out the fabric. Successive layers of glass were applied with an inch or so overlap. The glass application was carried up a meter on the vertical walls.

Obvious holes in the tank bottom were patched with steel plates. Surface preparation was by abrasive blasting to NACE 2, SSPC-SP-10. Delays after initial blasting resulted in some areas requiring re-blasting to remove flash rust.

When then glass and epoxy application was completed the entire lower surface including the lower 1 meter wall area was sprayed with BIO-DUR 560J, (upgraded in the same way as BIO-SEAL 192J), at a nominal thickness of 20 mils/500 microns.
